PRESSURE VESSEL & COLUMN INSPECTION REPORT

Report # : IR171002GENa

Plant	Conn Lake	Op Unit	EC-NO		System / LSD:	10-31-063-07w4	
Equipment #	66046993	Tag #	-		Asset Type	Separator	
Description	Inlet Separator		Prov. Insp. #	A	2861535	Serial #	1095 V100
Manufacturer	Plains Oil Ltd.		CRN	K8706.2		Year Built	1993
MAWP	4960	KPag	@	38	°C	MDMT	-29 °C
Code	ASME VIII	Fluid Service	Natural Gas		Sweet	PWHT	No
Internal Access	No	Insulated	No			Internal Coating	No
Operating Pressure	30		KPag	Operating Temp		10	°C

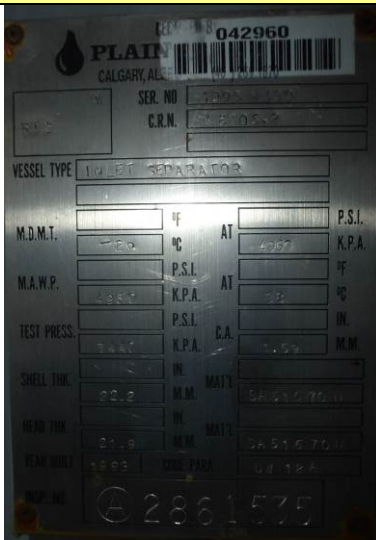
Nameplate

The nameplate is intact and legible.
